Installation instructions For set # 3.3188 2004 Pontiac GTO

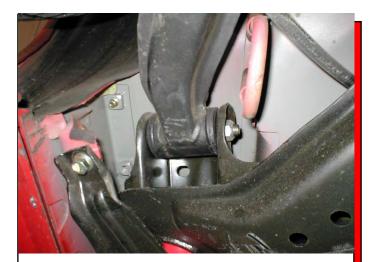
The outer position bushing has no outer metal shell that needs to be pressed out. The I.D. of control arm is Ø1.608, use something smaller when pressing out the old bushing. The O.E. rubber bushing is not bonded to the control arm. Trim off the flanges of the rubber bushing (both sides) and press out the bushing. Apply grease to all metal parts that contact the polyurethane bushings. Grease P/N's 2595 and sleeve P/N 15.10.180.39 and insert into the control arm.

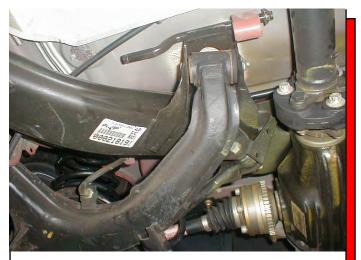
The inner position bushing has an outer plastic shell that needs to be pressed out. The I.D. of control arm is Ø1.608, use something smaller when pressing out the old bushing. Trim off the plastic flange of the shell and press out the bushing. Apply grease to all metal parts that contact the polyurethane bushings. Grease P/N's 2598 and sleeve P/N 15.10.180.39 and insert into the control arm.
