INSTRUCTION SHEET FOR SET #7.1115 NISSAN MAXIMA

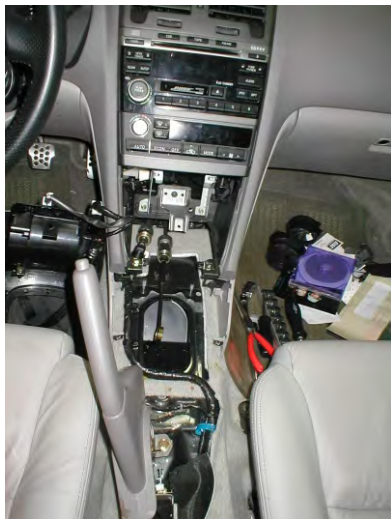
PIC 3

- Carefully unclip center trim panel. **Pic 1**
- Unsnap the shift boot from the trim panel and set to side.
- Remove screws for the center console and remove console. **Pic 2**
- Remove four nuts for plastic shifter bracket, now remove shifter Banjo bushing.
- Don't forget to also replace the banjo bushing out in the engine bay. **Pic3**

- Place the shifter bushings as per diagram below. First place the existing OEM washer down over the stud at four positions. Now place our **#1189** bushing over the OEM sleeve. Now set the shifter bracket down over the studs. Push our **#1188** bushing down into the bracket and now use the OEM nut to tighten bracket down. Install the banjo bushing for the main shifter cable at both the shifter location and out in the engine bay. **Pic 3** NOTE: To ease install, push **#1187** in with tapered side first.
