INSTALLATION INSTRUCTIONS

Resonator Upgrade Pipe

MAKE: Ford
MODEL: F-150
YEAR: 2021
ENGINE: V6-2.7L(tt)&3.5L(tt)/ V8-5.0L

49C43131

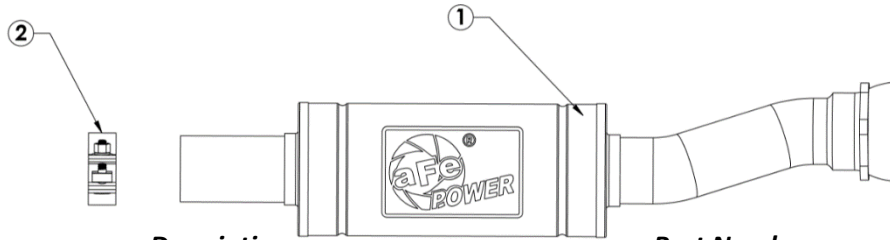
Item	Description	Part Number	Quantity
1	Resonator Assembly	05-244134	1
2	Clamp, Band; 3"	03-50415	2

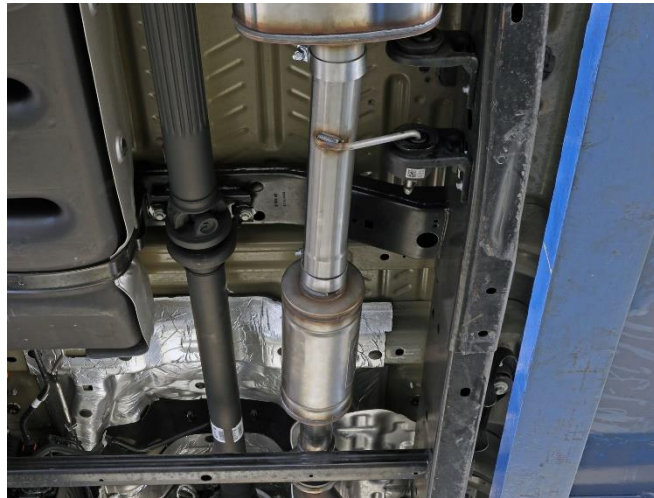
Install band clamps to proper torque specifications of 40-45 ft-lb.

2. Secure vehicle on jack stands (refer to your manual for specified jack stand positions).
3. For faster installation, spread out the parts of the exhaust alongside your vehicle as shown in the diagram above.

5. Install the aFe POWER Resonator Assembly using the O.E. flange bolts and the provided clamp. **Do Not Fully Tighten.**
6. Ensure that all the components of the aFe POWER exhaust system are aligned and are at a safe clearance from all wires, hoses, brake lines, body parts, and tires.
